**Death in the line of duty...****NIOSH**
Fire Fighter Fatality Investigation
and Prevention Program

July 6, 2011

Two Career Fire Fighters Die and 19 Injured in Roof Collapse during Rubbish Fire at an Abandoned Commercial Structure – Illinois

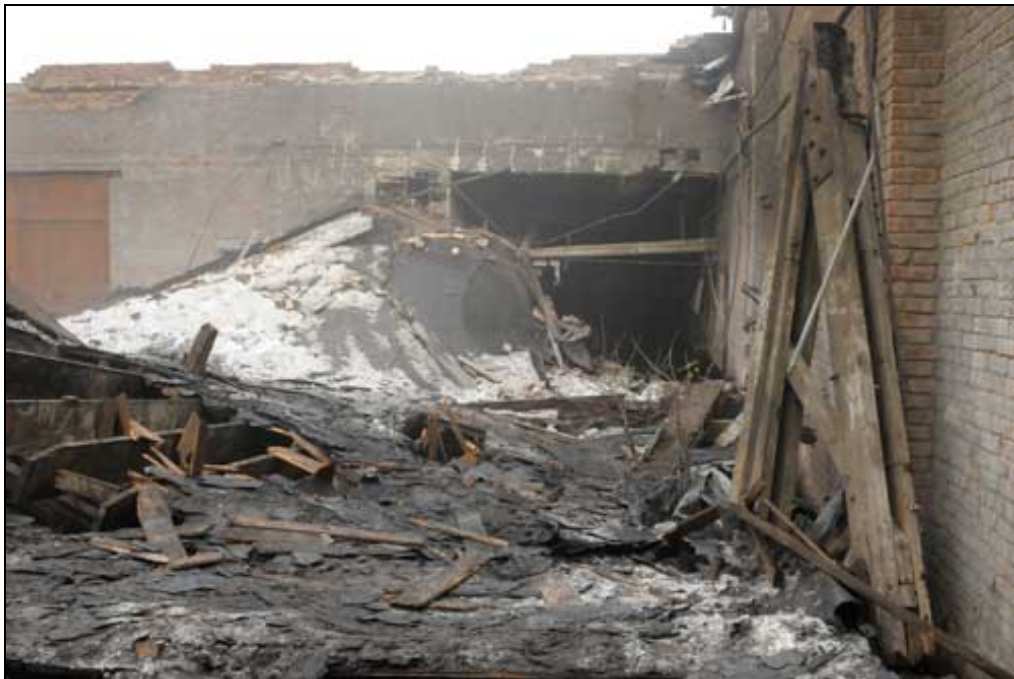
Collapse scene as viewed from building rear facing building front. Note portion of bowstring truss leaning against wall at right side of photo.
(Photo courtesy of fire department)

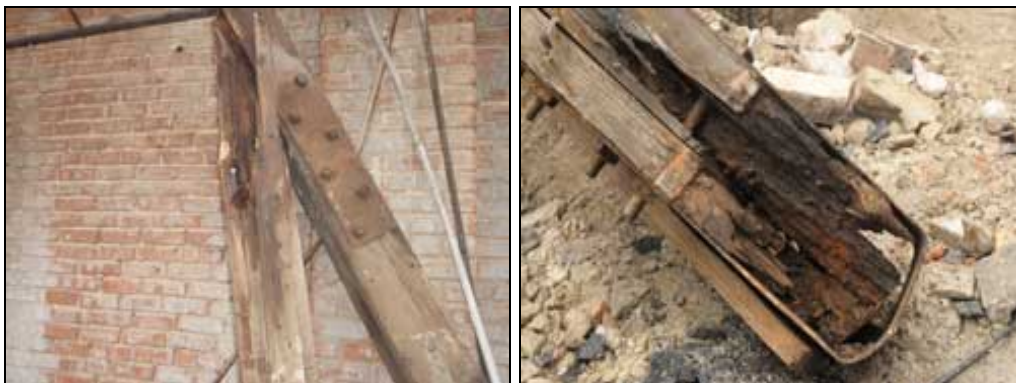
Photos show the deteriorated condition of bowstring roof trusses. Note the truss end in the left photo and the deteriorated condition caused by water damage in right photo.

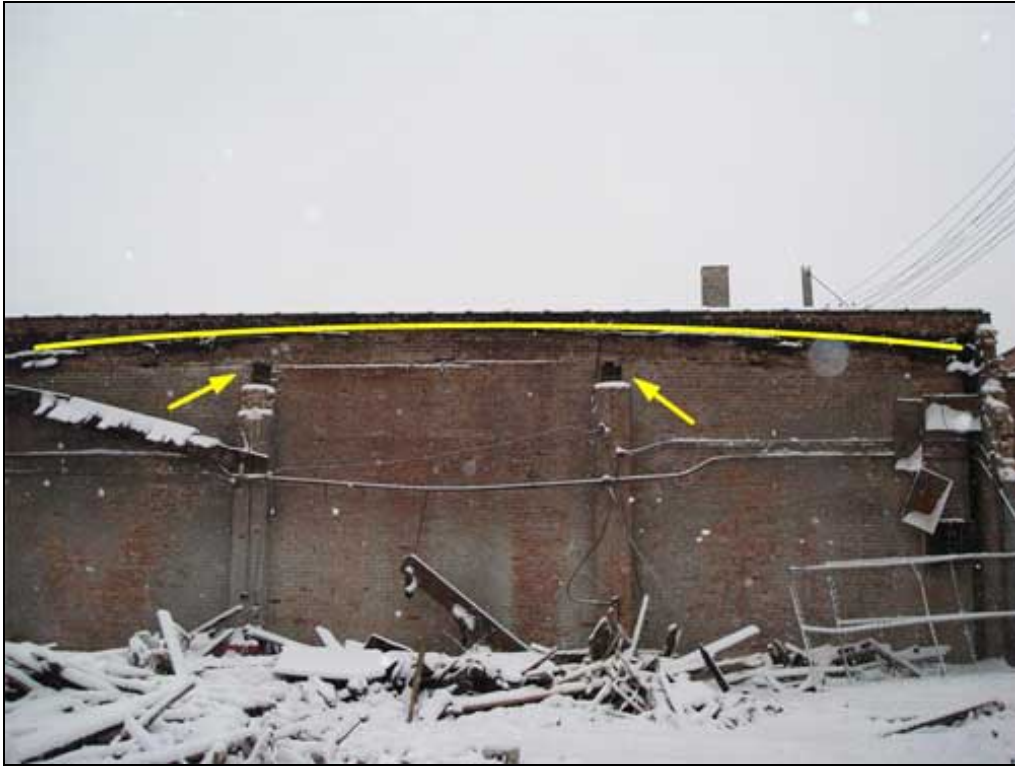
Photo 2. Photo shows the Sector 2 wall that supported western end of the bowstring truss roof. The two arrows indicate the truss-end pockets in the brick masonry wall at the top of the brick pilasters where the ends of the two bowstring trusses rested. The roof was supported in the middle by the two bowstring trusses while the north and south ends were supported by the front and rear non-load bearing walls. The line indicates the approximate curvature of the roof.
(NIOSH photo)

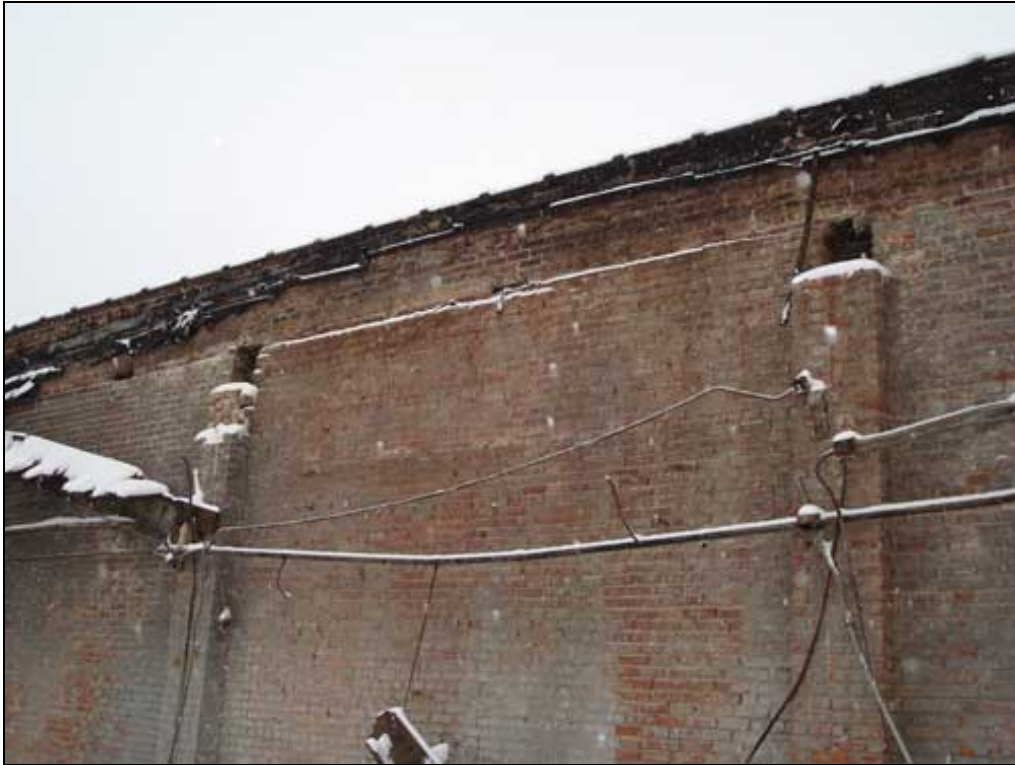
Photo 3. Photo shows the truss support pilasters built into the Sector 2 (west) wall. The Sector 4 (east) load bearing wall also contained support pilasters. The Sector 4 wall partially collapsed during the incident and was demolished after the recovery operations.
(NIOSH photo)

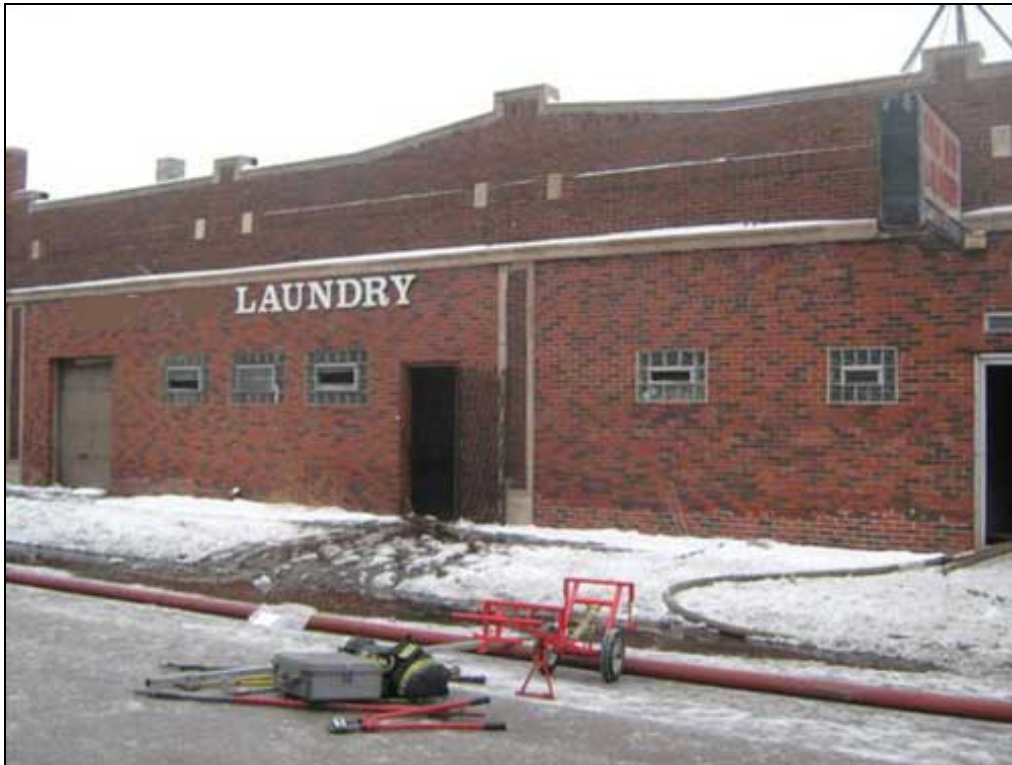
Photo 5. Front view of structure as viewed from the street (Sector 1). Buildings along the street appeared to be in good condition from this view. The deteriorated condition of the roof was not visible from street level. Photo taken the day of the incident.
(Photo courtesy of city Department of Buildings)

Some of the code violations cited in the 2007 written complaint included: failure to maintain parapet wall in good repair; failure to maintain lintel in good condition; failure to securely fasten loose plate glass in windows; failure to cut or remove weeds, grass and other growth; failure to remove accumulation of refuse and debris; failure to maintain roof in sound condition; failure to remove sewage and stagnant water from basement; failure to maintain exterior walls free from holes, breaks...or other conditions that might admit rain or dampness; and, failure to maintain building in a structurally safe and stable condition.

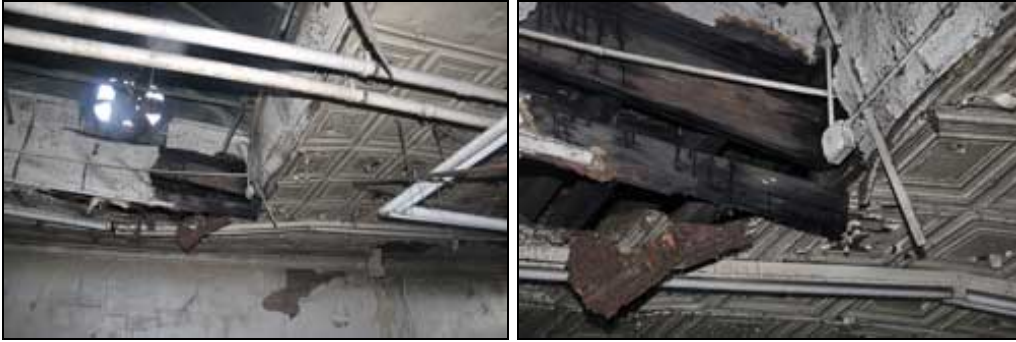
[Photo 6](#) and [Photo 7](#) show some of the deteriorated ceiling conditions observed by fire fighters when they entered the front portion of the structure during the incident. This deterioration appears to have been caused by water penetrating the roof.

Photo 6 and Photo 7. Photo 6 (left) and Photo 7 (right) show the deteriorated ceiling conditions inside the front part of the structure.
(Photos courtesy of fire department)

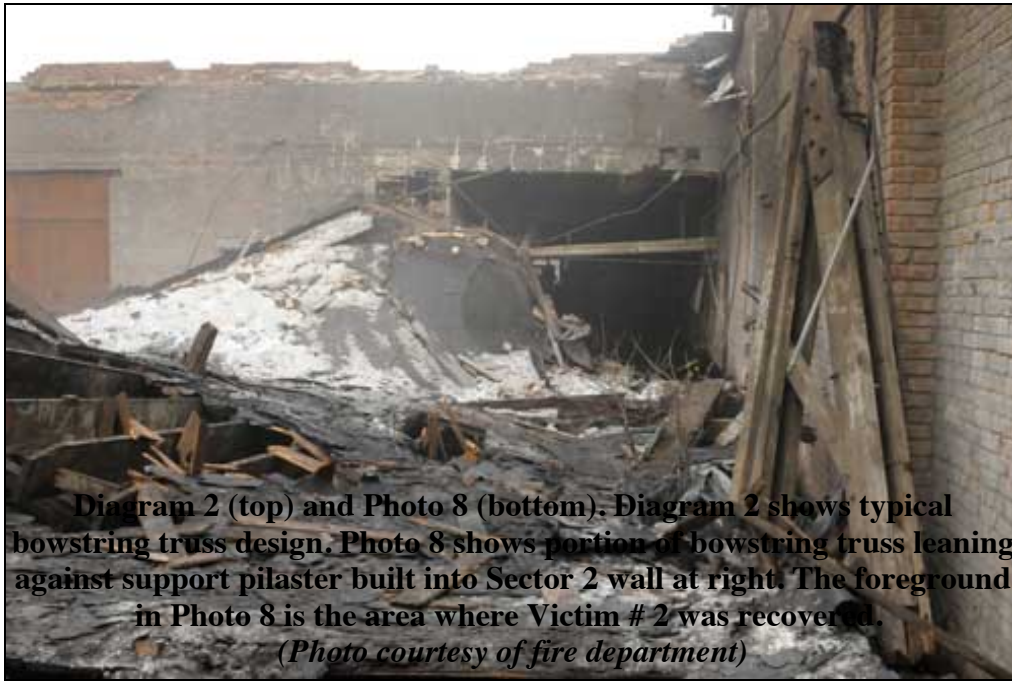
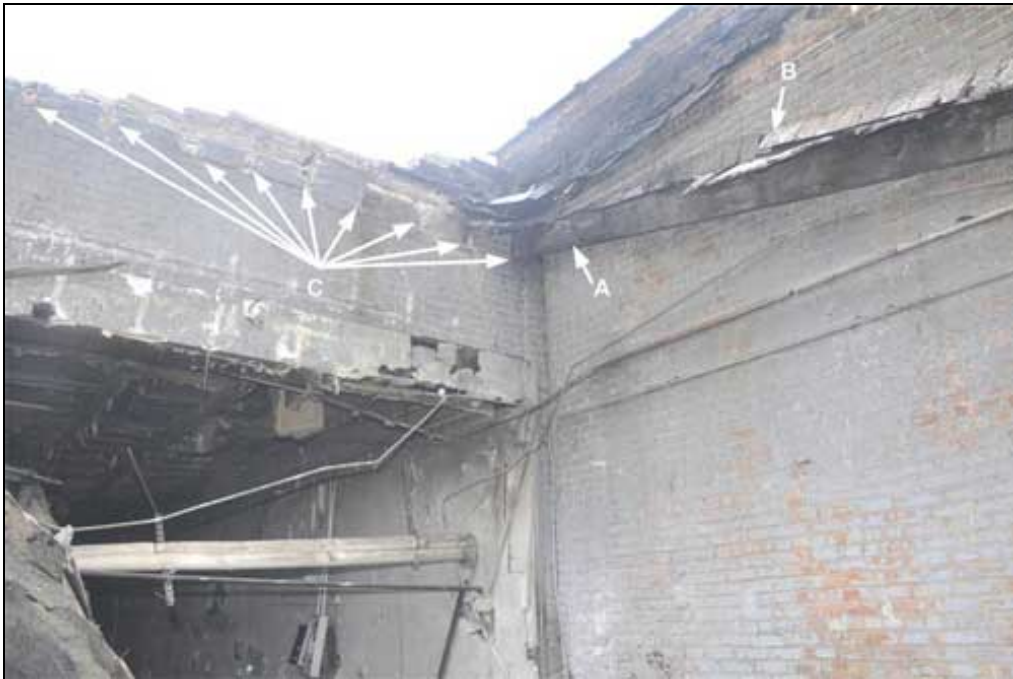
Photo 9. Photo shows connection of the front and rear portions of the structure as viewed from Sector 3 facing Sector 1 (same view as Photo 8).

Note the roof purlin still attached to the Sector 1 wall (A) and the remains of tongue and groove roof deck boards attached to the top of the purlin(B). Also note how the end of the remaining purlin sets into a recessed pocket in the brick masonry wall and the locations where other roof purlins pulled away from wall (C). Vertical marks on the wall above the opening indicate where the roof purlins contacted the wall as the roof collapsed.

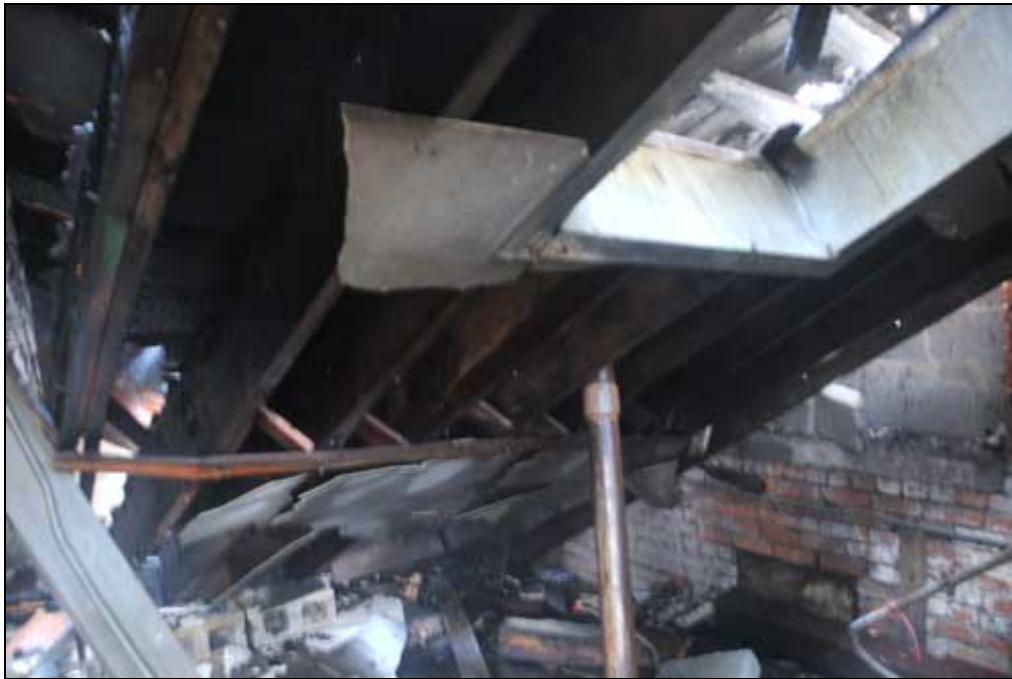
Photo 10. Photo shows the scuttle hole in the roof where the E-126 lieutenant looked into truss void for fire extension. Note condition of roof rafters indicates little fire damage in this area.
(Photo courtesy of fire department)

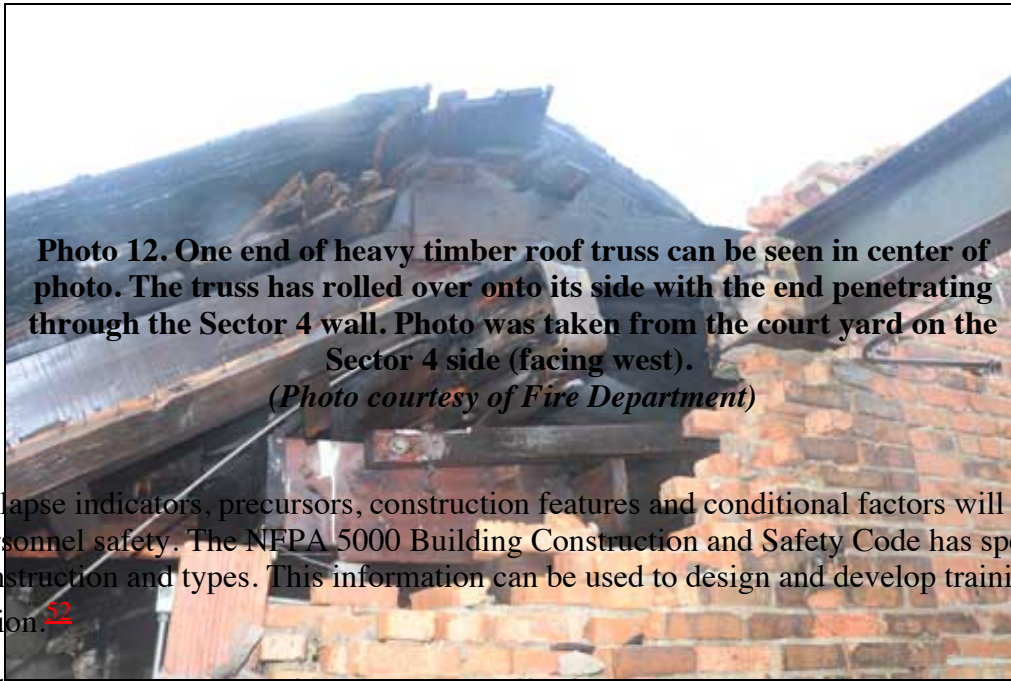
Photo 12. One end of heavy timber roof truss can be seen in center of photo. The truss has rolled over onto its side with the end penetrating through the Sector 4 wall. Photo was taken from the court yard on the Sector 4 side (facing west).
